Asset Recovery Information

Alvey 880 Palletizer
Serial Number #01-KH15
Asset # CP000153
Location: Ross Products Division, Columbus Plant
Contact: Kelly Niekamp 614-624-6213

Manufacturer Audit

880 Palletizer

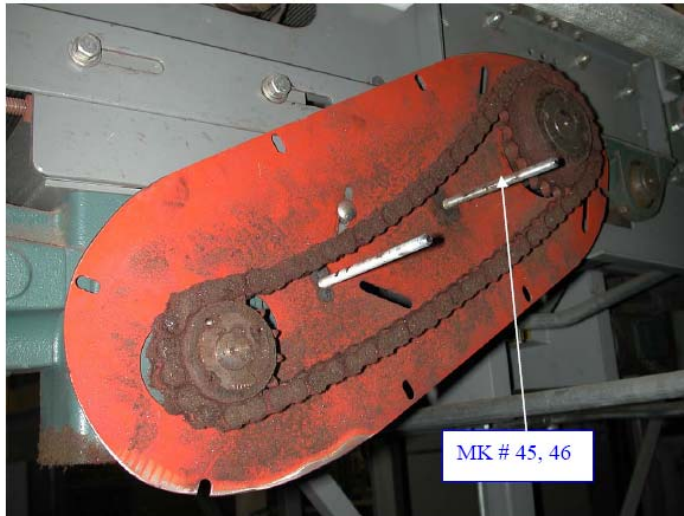
- 1) The motor drive chain is rusted, in very bad condition, and needs to be replaced.
- 2) The drive sprocket is still okay, but the driven sprocket has worn teeth.
- 3) Lots of cleaning is needed in the infeed area.
- 4) Chains must be kept lubricated.

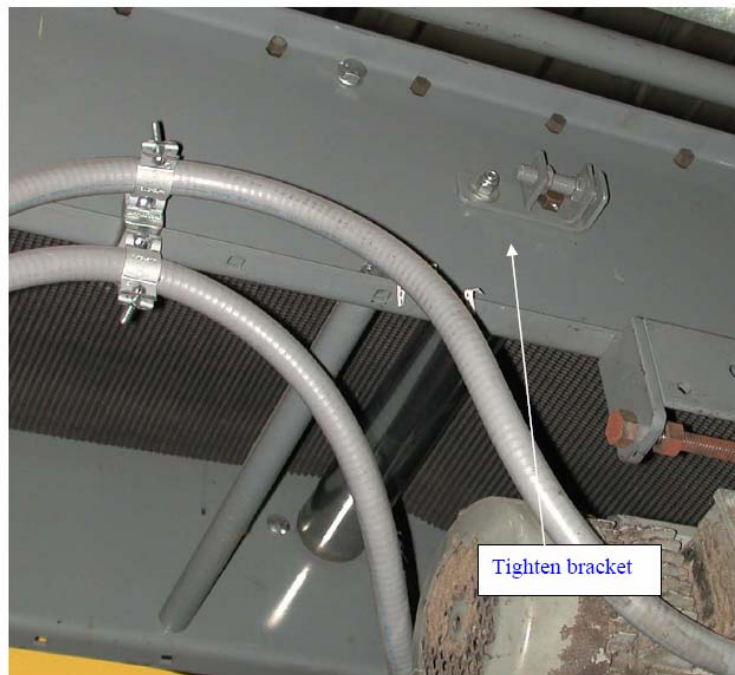
- 1) The incline belt is very worn. It is critical to the palletizer operation that the belt hold back the cases adequately. Smooth belts allow too much case back pressure against the cases crossing the spacer belt. Since the infeed was not provided by Alvey, part numbers are not provided. Nevertheless, the belt will need to be changed.
- 2) The tracking roller's mounting brackets are loose on both sides of the conveyor, especially on the left. The mounting brackets need to be tightened up. Loose mounting bolts will cause belt tracking problems.

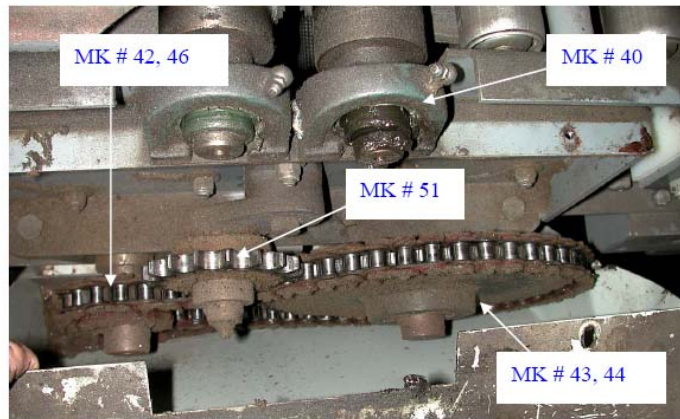
- a) The two belts feeding the palletizer are slaved together by sprockets and chain. The slave drive unit is very dirty. Cleaning is needed.
- b) The large driven sprocket has worn teeth and needs to be changed. The small sprocket is marginal.
- c) The chain tensioner has a worn sprocket that will need to be changed. The chain is worn, rusted, and stretched. New chain is needed.
- d) The pillow block bearings have blown seals. Once the seals are blown, the grease will tend to leak out. Aside from creating a mess, it should not create a problem if they are kept greased. FKI uses sealed-for-life bearings, so new bearings would not have to be greased. Considering the time and effort spent greasing bearings, it may be good to consider replacing the blown bearings for new.

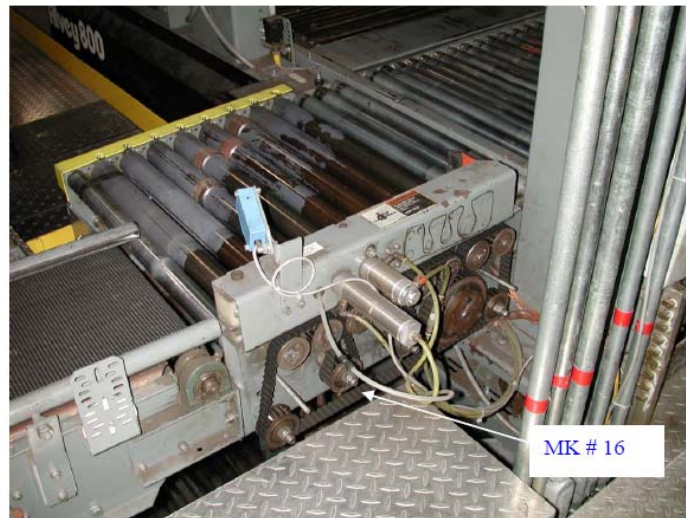
- 1) The guard for the Cog Belt drive is missing. It needs to be replaced.

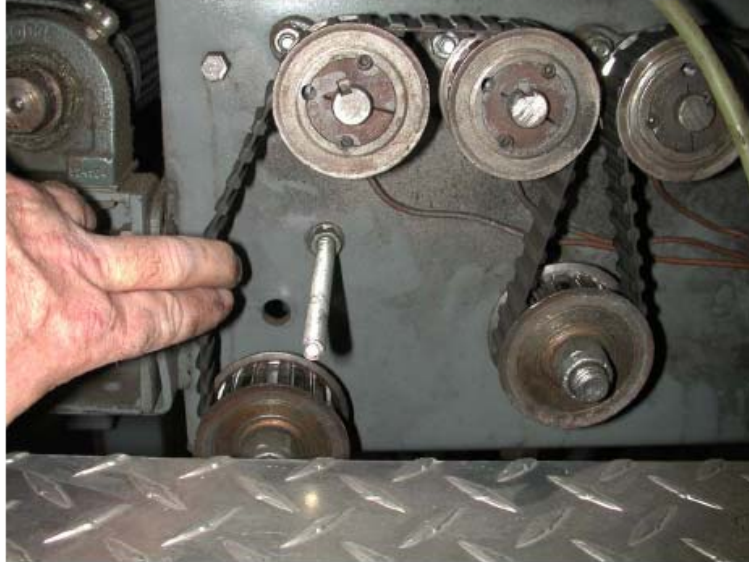
- 2) The belt is too loose. It needs to be tightened up. There is some belt misalignment.

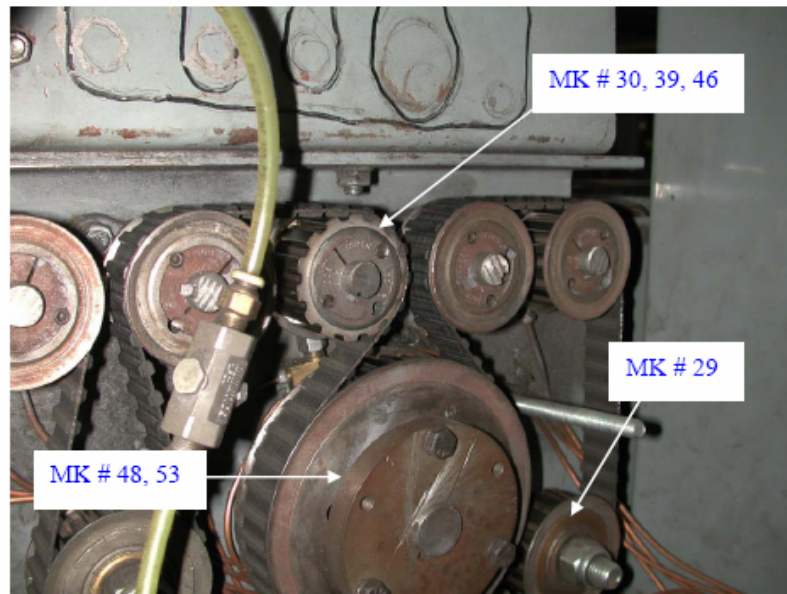
- 3) The large cog gear has a bent flange. Replacement would be the best option.
- 4) The lower left and right gear idlers have worn bearings. They need to be changed.
The lower right side idler is missing its flange.
- 5) The third from last gear idler (top row) is missing the flange.

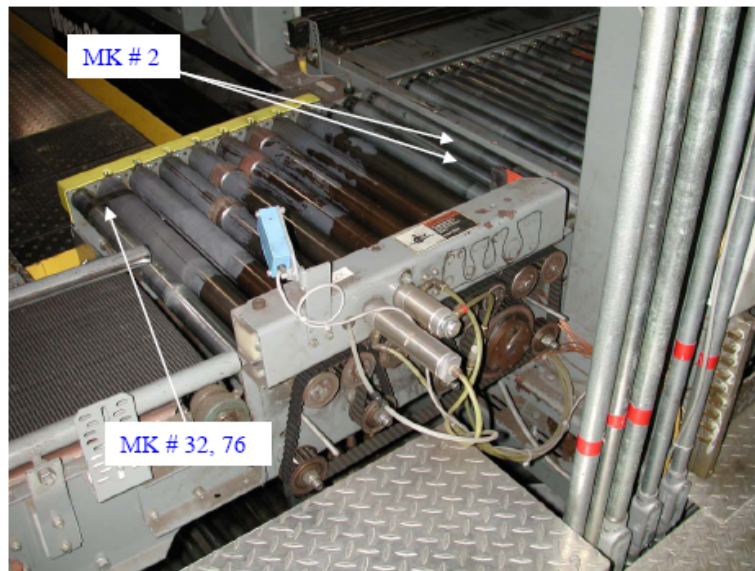
- 1) The first roller is powered by slaving it off the powered rollers. The use of a tracking band, and activator band is required. The tracking band is missing, and the activator band is worn. Both need to be replaced.
- 2) The second from last roller has quite a bit of bearing wear. It is now marginal.
- 3) The third from last roller has an excessively worn bearing. It will need to be changed right away.

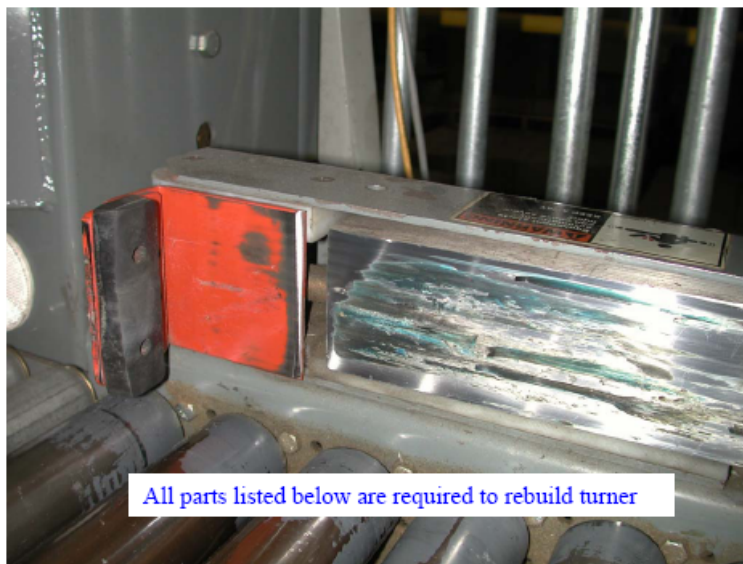
- a. The air cylinder mounting bracket is loose and needs to be tightened down.
- b. There is a rather severe air leak. It seems that the air cylinder seals might be leaking.
- c. The bump turner wear parts are now marginal and should be considered for replacement.
- d. The bumper pad is worn

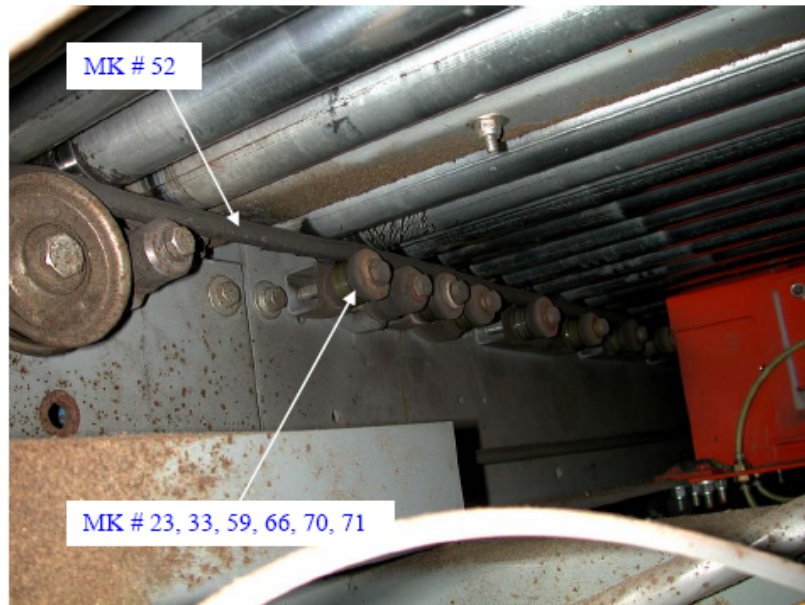
- 1) The V-belt is cracked in many places. A new V-belt is needed.
- 2) The V-belt idlers are worn and need to be changed.

Since they hold the V-belt against the bottom of the rollers, the snub idlers should be checked routinely. The reason is that, as the snubs wear, they press against the V-belt unevenly causing premature failure of the belt. Worn or incorrectly tensioned snubs will also contribute to roller bearing failure. By not keeping the proper tension on the rollers, the shafts can jump up and down. In a relatively quick time the shafts wallow out the side frames. Since the snub rollers are inexpensive, the recommendation is to replace them once a year regardless of how they appear.

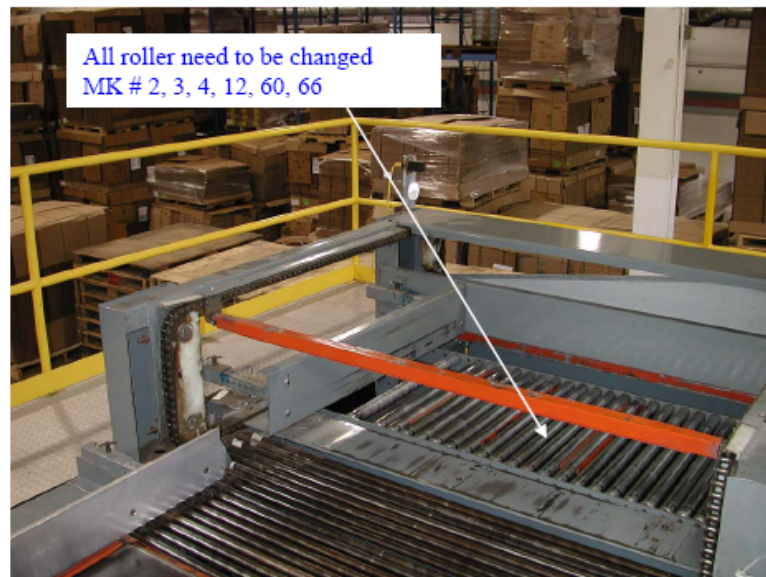
- 1) All the rollers need to be changed because of worn bearings. Some of the roller bearings are completely gone (e.g. 11th roller).

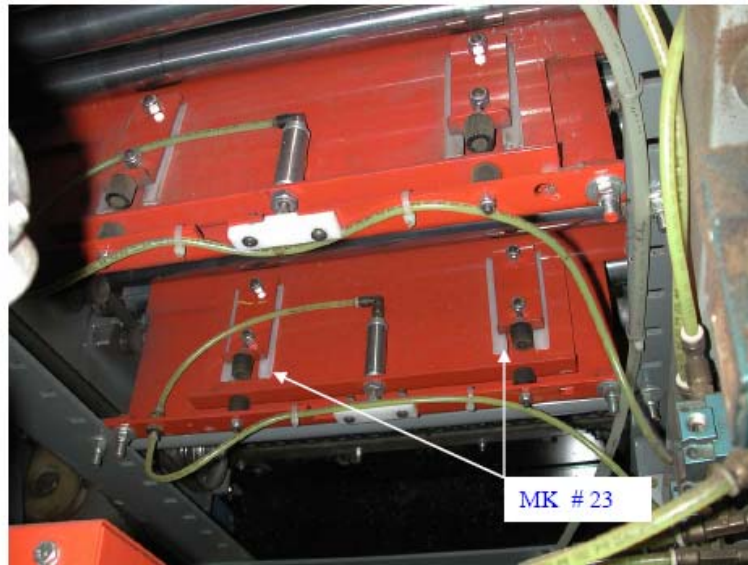
- a. New wearstrips are needed on the case stops. The blades are too loose. It is best if the stop blades do not contact the rollers. In the interim of replacing the wearstrips, tightening the mounting bolts may help.

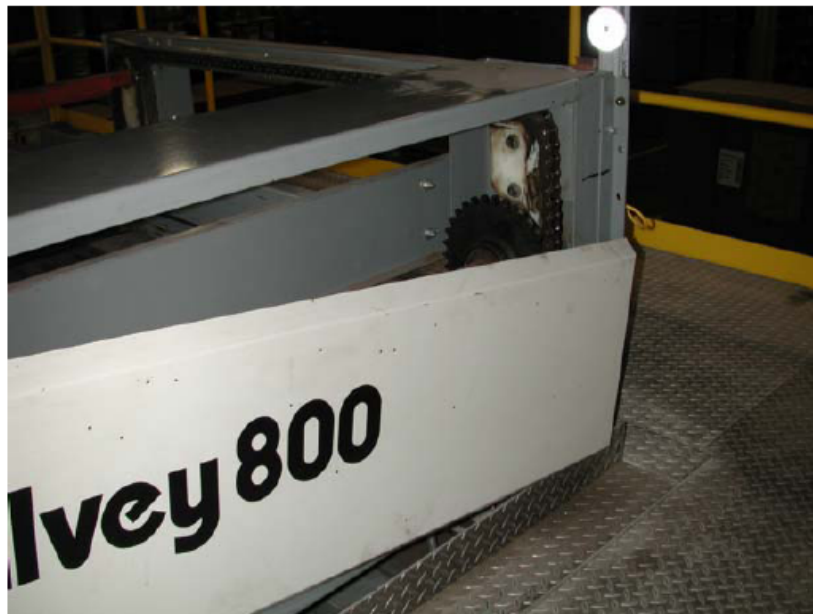
- 1) The guarding is not in the proper position. It will need to be put back on correctly before running the machine.

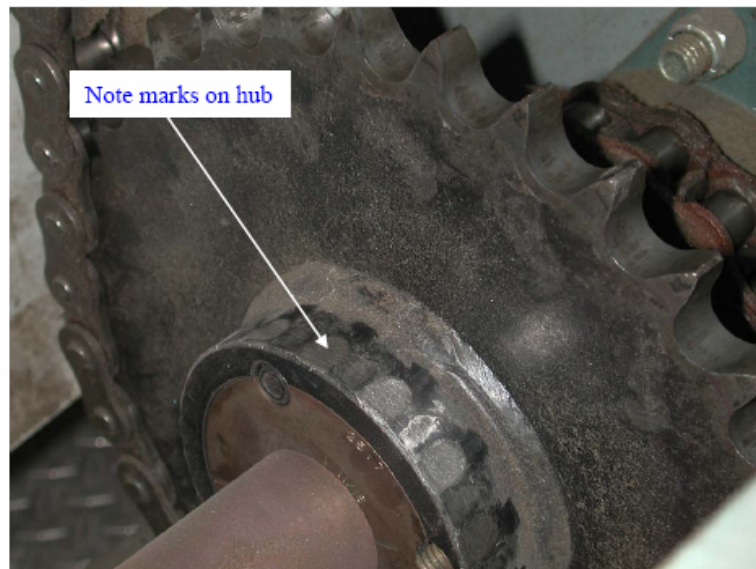
- 1) The hubs on the large drive sprockets are exhibiting wear marks indicating that they have been hit by the pusher bar clevis pins. This results when the pins are not installed in the correct direction. Please refer to the note about installation of pins under the section on the pusher bars. (Page 31).

Typically, when the pins are put in the wrong way, chain tension must also be loose, otherwise the chains will struggle to pull the clevis pin past the hub. It has been reported in some cases, that when the chains were tight, the clevis jammed on the hub, stalling the motor.

Running loose chains will result in shortened life of chains, guides, pusher bar end connection blocks, and chain tracks.

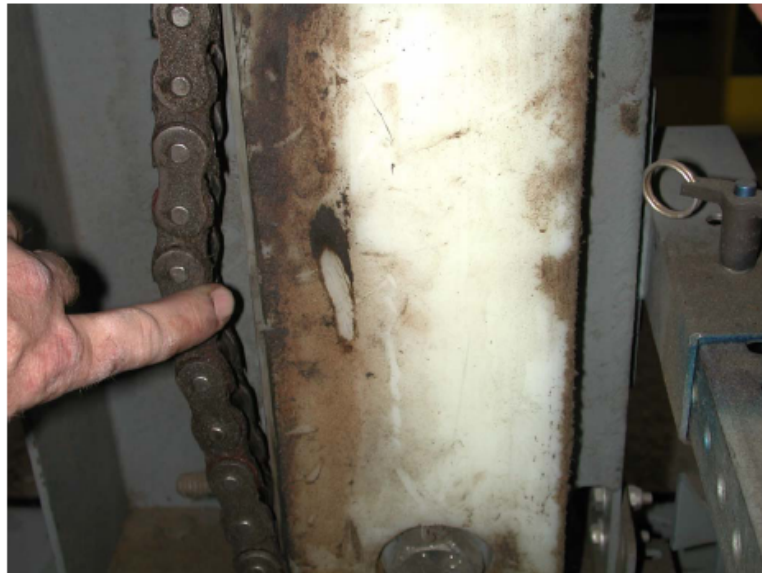
- 1) The pusher bar chains are considerably too loose. They need to be tightened.

It is important that the chain tension is adjusted the same on both sides of the machine. Chains should be taut. A good measure is to pull the chain away from the end idler block. The chain should not be lifted off the idler block more than $\frac{1}{4}$ " or so with moderate finger pressure.

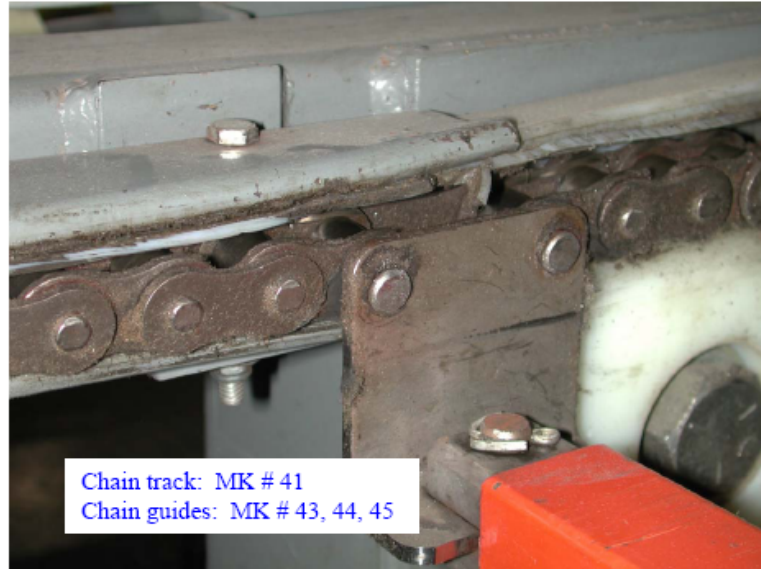
- 1) The lower left metal chain track is loose. The mounting bolt is gone. It will need to be replaced.
- 2) The upper and lower right side chain tracks are loose.
- 3) The upper left track is bent and the plastic guide is gouged.

Bent tracks need to be changed. Although the metal can be bent back to proper position, once stressed, it will never be able to hold proper pressure on the guide. Because the metal is fatigued, it will quickly bend again. Changing the track is the only good solution.

- 4) All the plastic chain guides need to be changed.

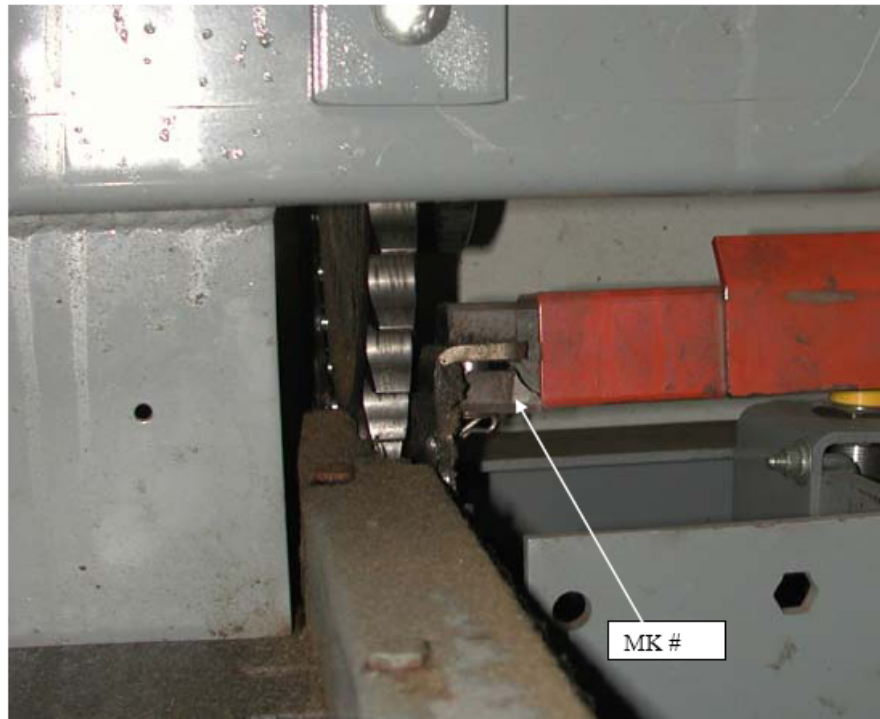
- 1) One of the right side end connection blocks is broken. It needs to be changed immediately

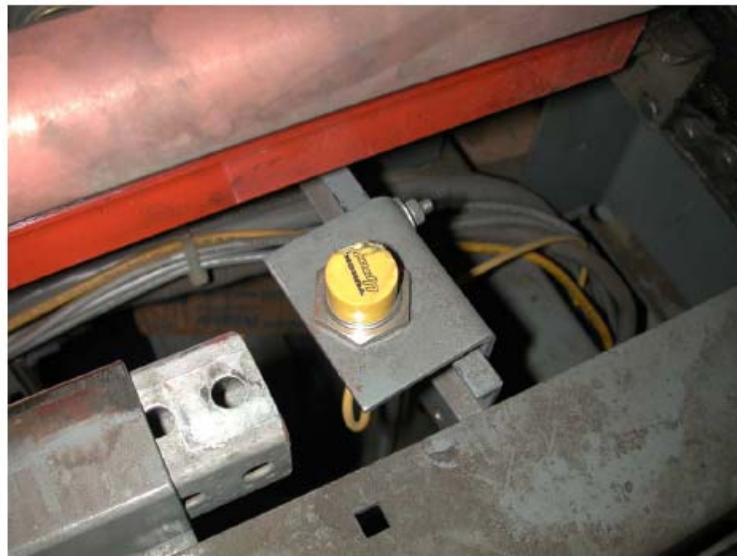
- 1) The face of the proximity switch (controls stopping position of the pusher bar) has been hit by the pusher bar. This happens when the chains are too loose. The switch is working, but whether or not the life expectancy has been shortened, is questionable. The recommendation is to consider having a new switch on hand in case of failure.

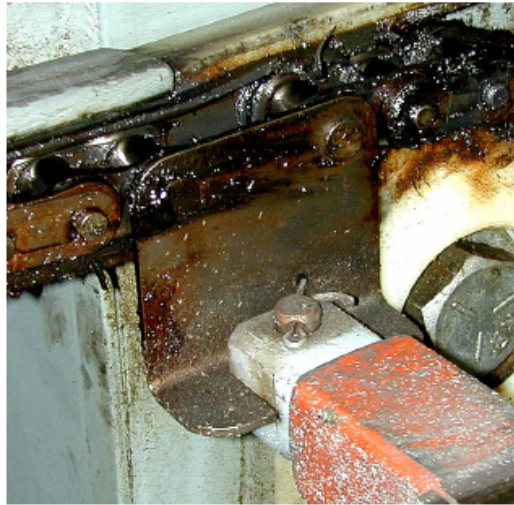
The clevis pin is shown installed in the correct direction. When the pusher bar is in the top position (as shown in this photo), the clevis pin is installed from the bottom. The cotter pins should be showing on top. Failure to install the pin in this direction will cause the attachment links to break in a relatively short period of time. It will also gouge the sprocket.

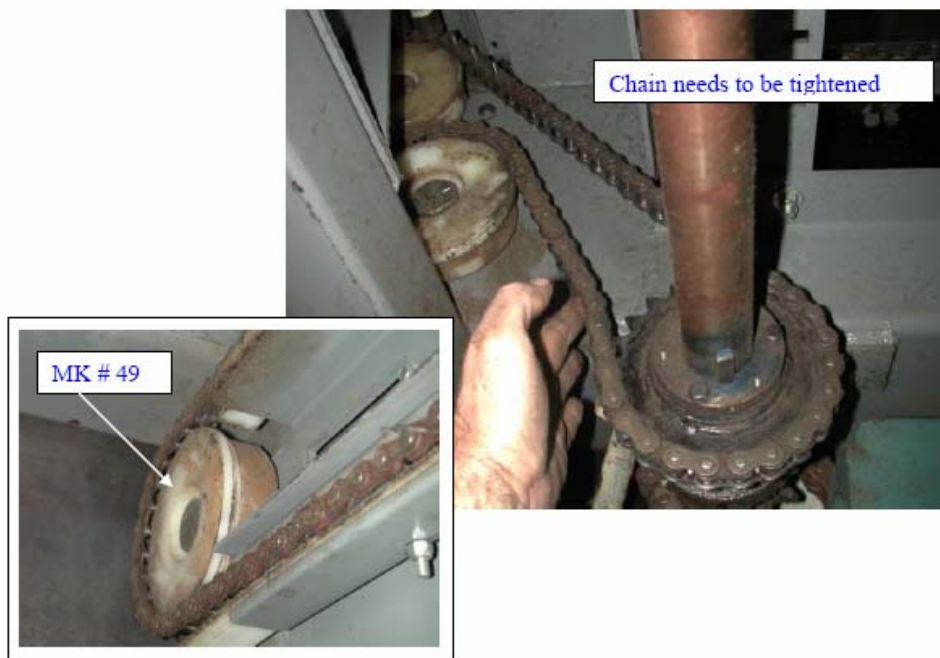
- 1) The right side chains are too loose. This must be corrected as soon as possible.
- 2) The right side end idler is worn and needs to be replaced right away.

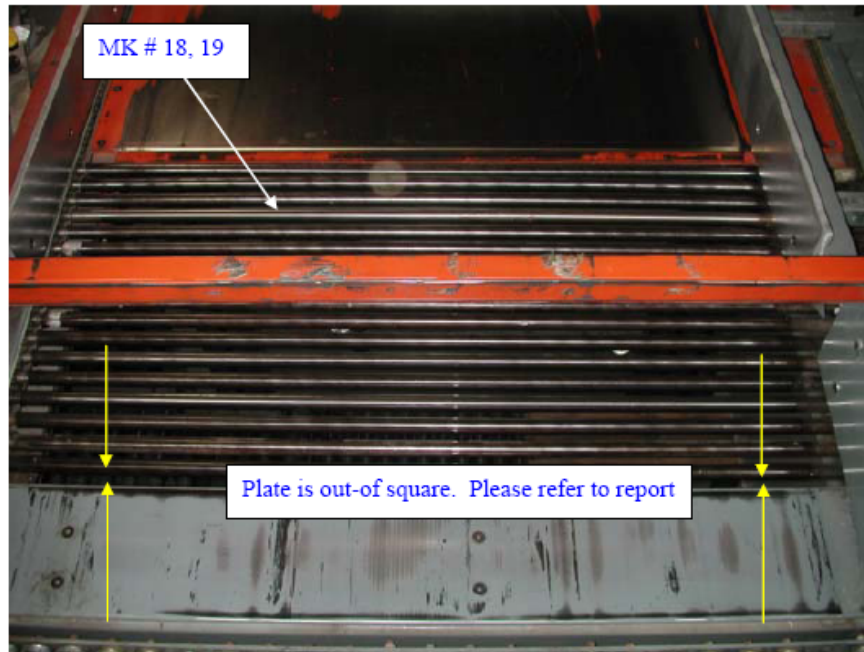
- 1) The apron plate is in good condition but it is closing too far. It needs to be adjusted so that it doesn't hit the tubes when closed.
- 2) The apron plate is out-of-square by about a half link. This could perhaps be accounted for by the right side chains being loose. Once the chains are tightened up, the plate should be checked to make sure it is square. If it isn't, perhaps the chain has stretched more on one side, or there may be an extra link on one side.
- 3) Counting from the pusher bar area, the 2nd, 8th, 9th, and 17th tubes are bent and will need to be changed. The 14th tube is marginal.

For good product transfer (especially small cases), it is important that the tubes be perfectly straight and spin freely.

- 4) The tubes ends are showing some wear, but do not have to be changed yet.

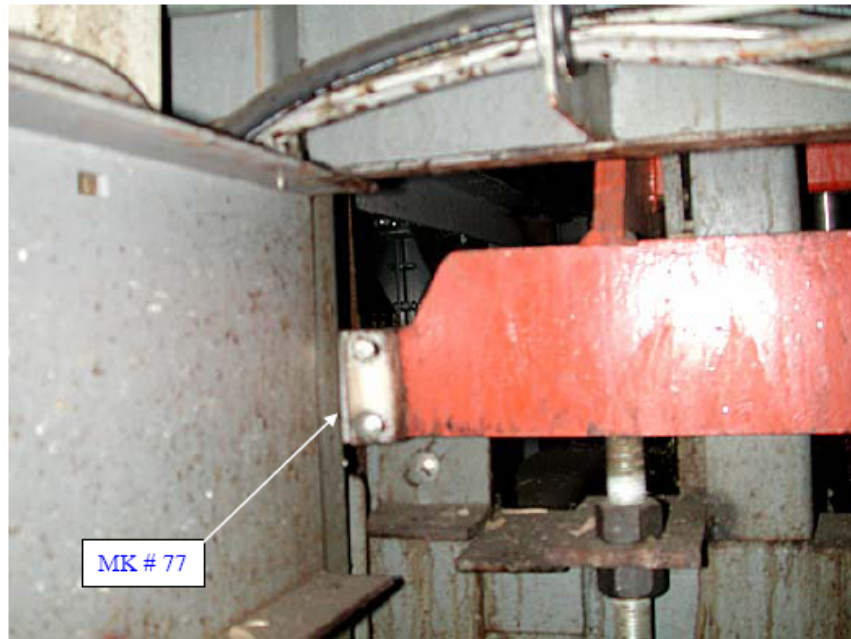
- a. The hoist table guides are very worn and will have to be changed.

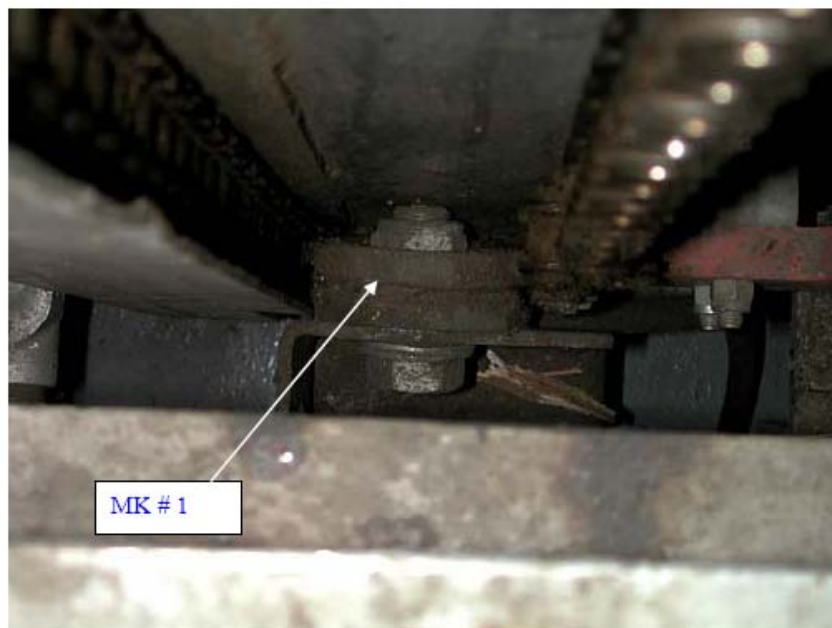
- b. The table is out-of-level. For best operation, it should be leveled.
- c. The lower right side hoist chain idler has a bent bracket and is worn. The bracket must be fixed and a new idler installed.
- d. The transition rollers between the hoist table and the full load discharge section are sitting crooked. It seems that the frame is bent. This is probably not a major problem but it will, of course, push the load to one side while exiting the machine. It can be easily fixed if it becomes a problem.

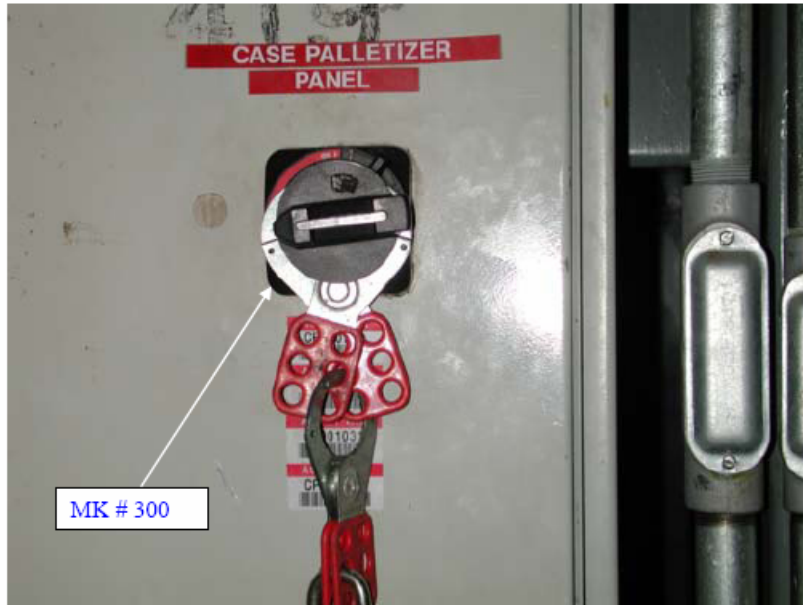
- a. The door handle on the main disconnect on the electrical enclosure under the case infeed area, is broken. A new handle is needed.
